<b>INSPECTION REPORT</b>	<b>Report Date:</b>	Nov 01 2008	<b>Overall Result</b>
		<b>Booking No.:</b>		
		<b>Inspection No.:</b>		
		<b>Client Name:</b>		<b>6 Pages</b>

<b>A.GENERAL</b>	
From: Wenzhou Trust Testing & Inspection Co., Ltd.(TTC) Contact: Vicky Lin Tel: 0086-577-88915592 Fax: 0086-577-88915610 Email:ttctest@gmail.com Inspector Name(s):COKE	To: Contact: Tel: Fax: Email: Copy To:
Service Performed: FRI	Ref. Sample Received Date: N/A

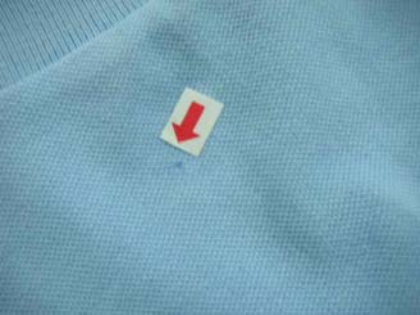
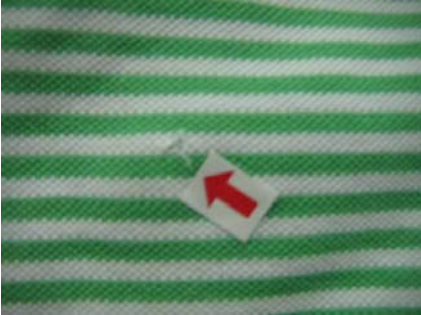
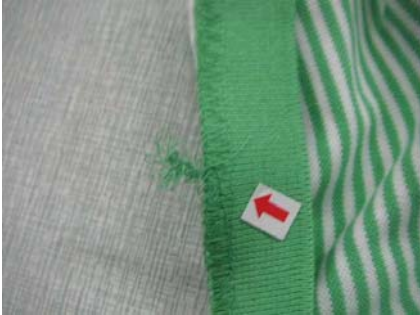
<p>Photo 16) color fly yarn</p>	<p>Photo 17) broken yarn</p>	<p>Photo 18) untrimmed thread ends</p>

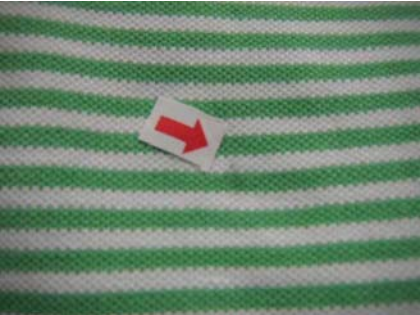
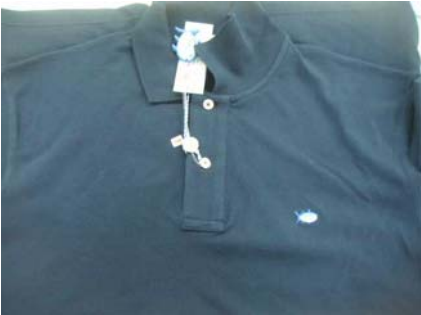
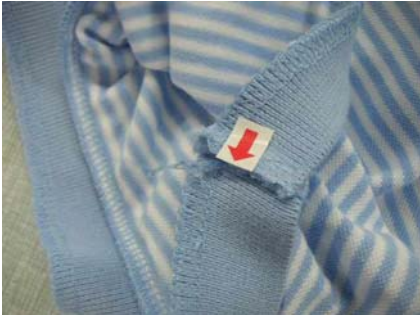
<p>Photo 19) dirty mark</p>	<p>Photo 20) slant front placket</p>	<p>Photo 21) untrimmed thread ends</p>

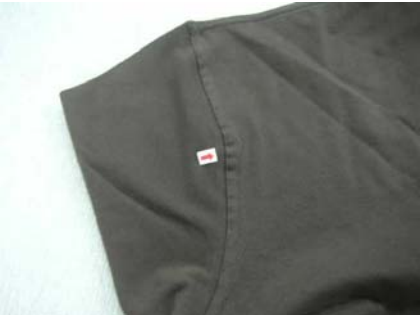
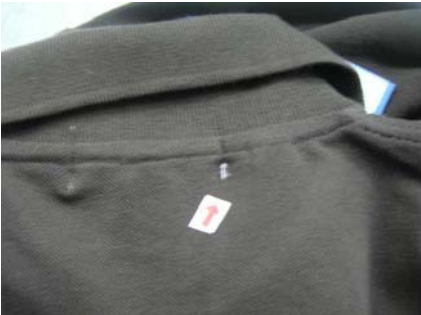
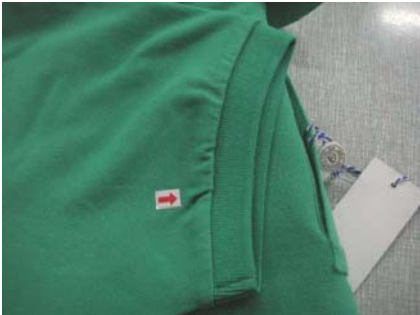
<p>Photo 22) puckering</p>	<p>Photo 23) exposed color stitches</p>	<p>Photo 24) puckering</p>

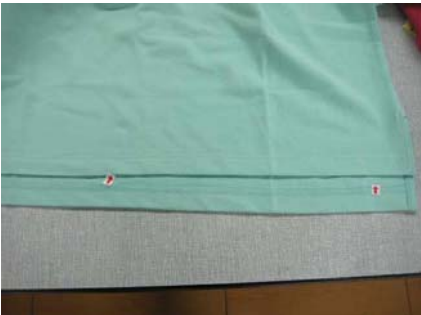
<p>Photo 25) puckering</p>	<p>Photo 26) wavy front bottom hem</p>	<p>Photo 27) slant front placket</p>

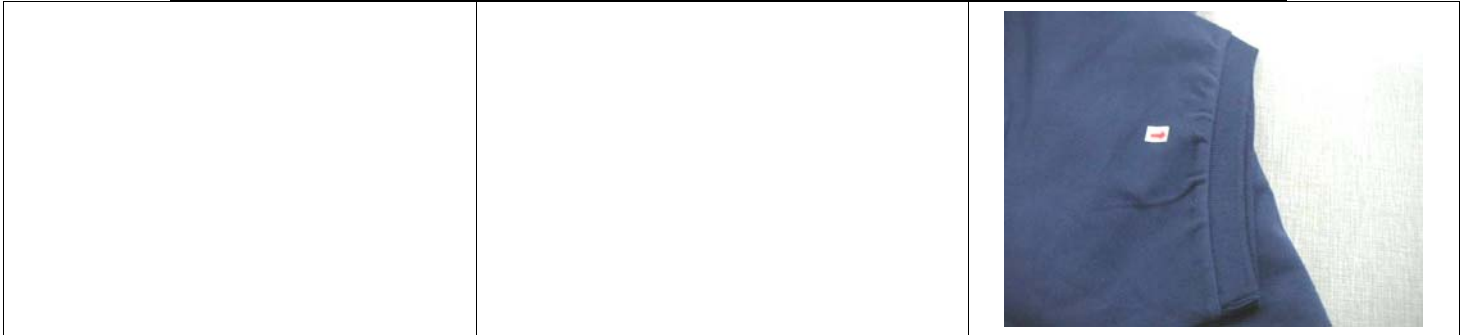
Photo 28) poor front placket shape

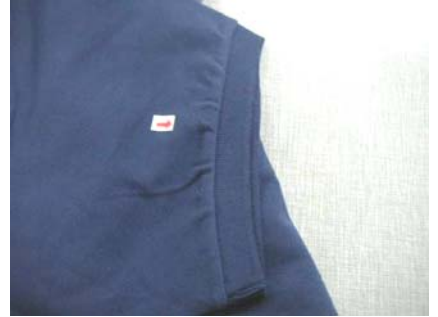
Photo 30) puckering

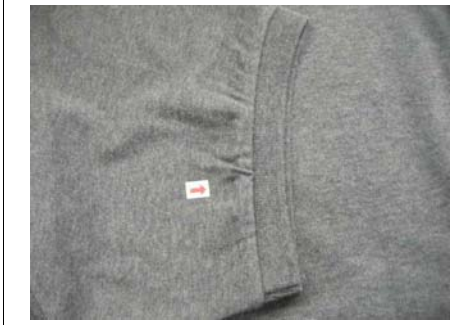
Photo 31) puckering

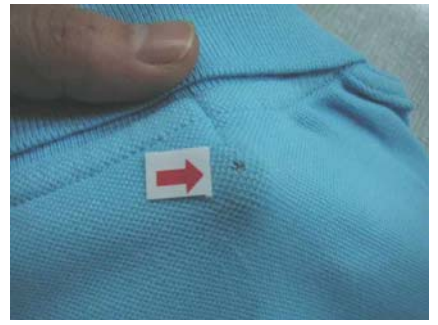
Photo 33) hole

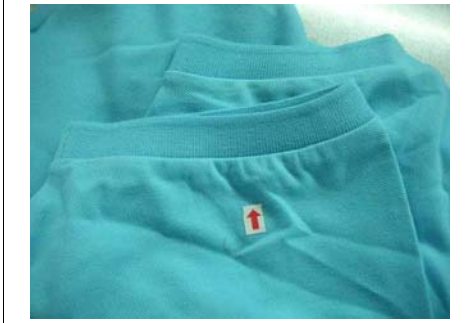
Photo 34) puckering

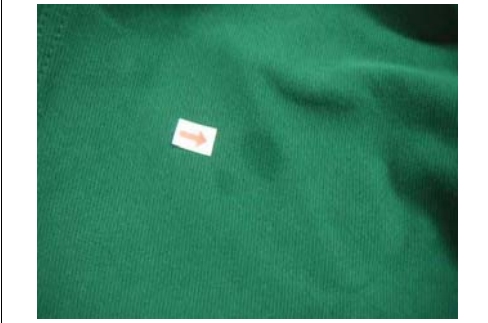
Photo 35) oil stain

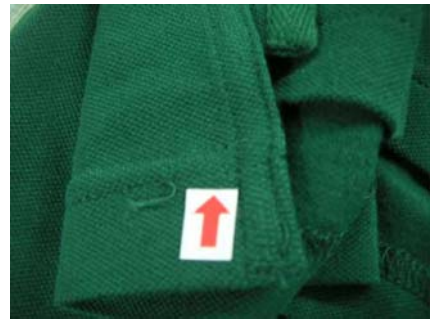
Photo 36) broken stitches

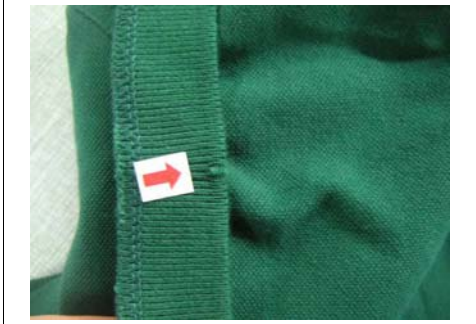
Photo 37) laddering (dropped stitches)

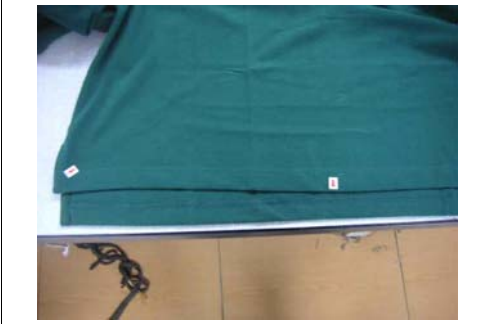
Photo 38) wavy front bottom hem

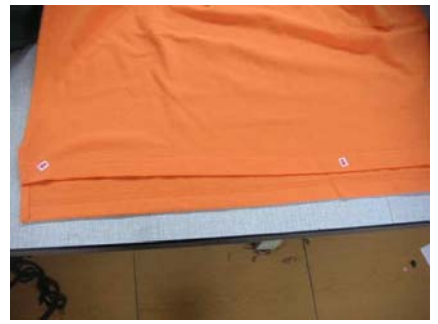
Photo 39) wavy front bottom hem
